*U.S. Department of Energy
Office of Legacy Management*

2006 Annual Site Inspection and Monitoring Report for Uranium Mill Tailings Radiation Control Act Title I Disposal Sites

December 2006

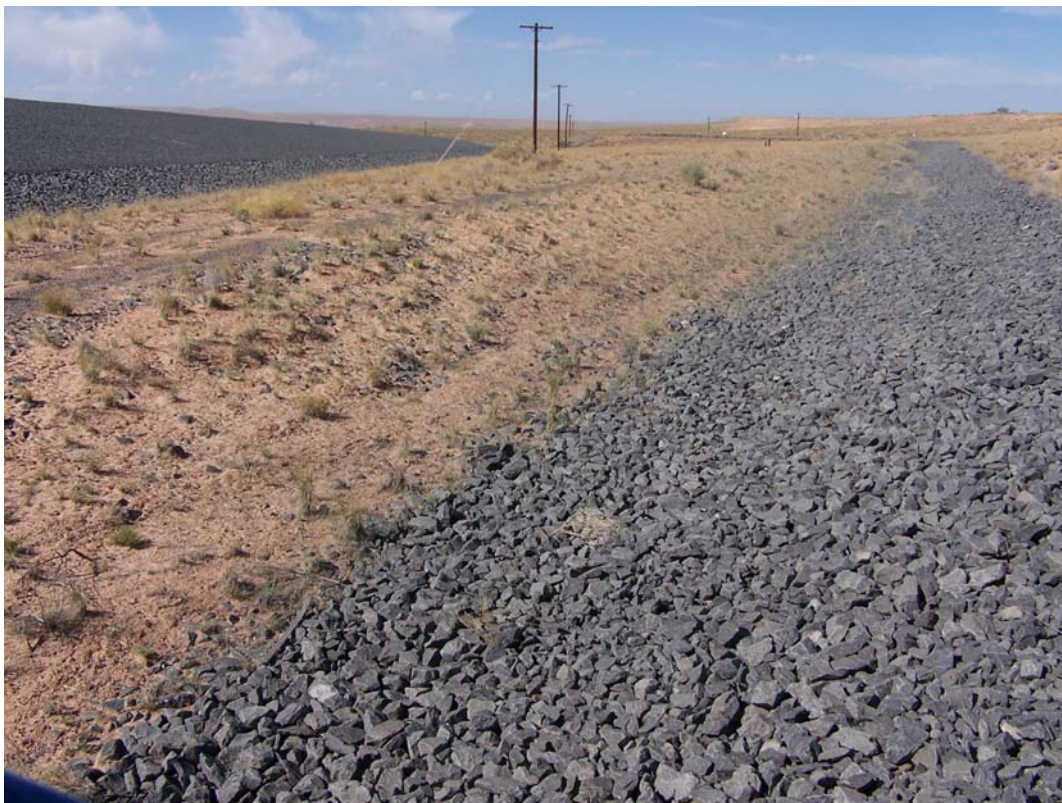
TUB 4/2006. PL-5. Sand accumulation and vegetation on the south bank of the diversion channel (reference photograph).

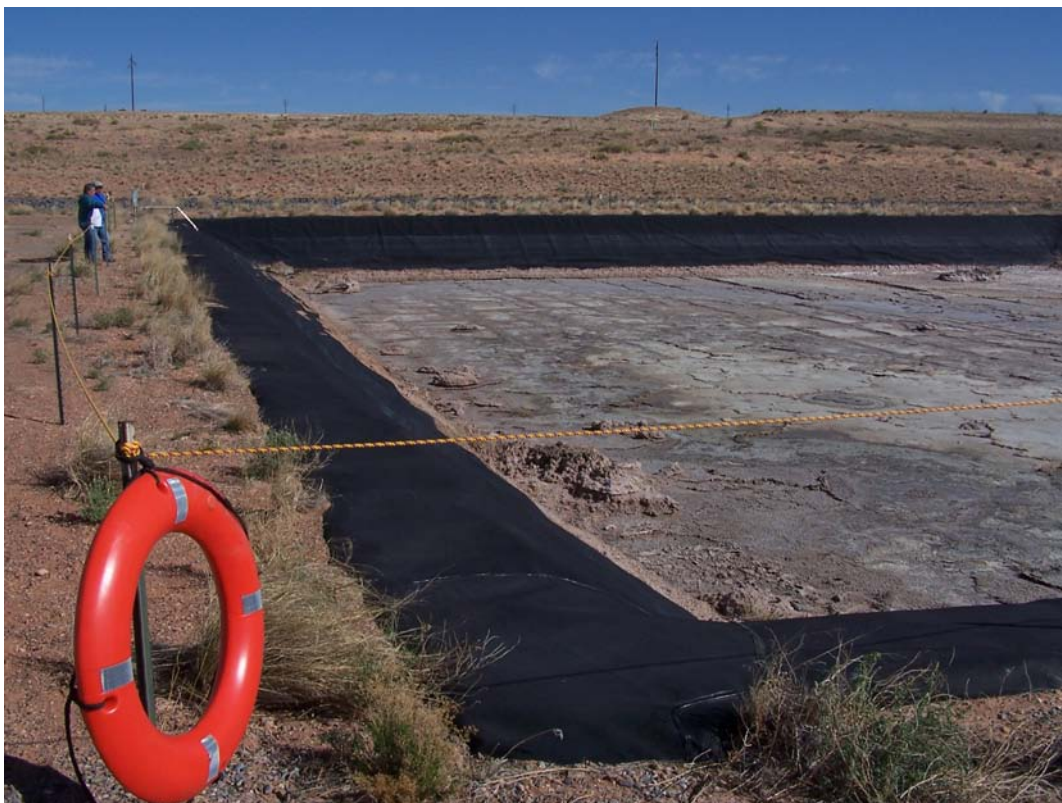
TUB 4/2006. PL-6. Evaporite deposits in the southwest inactive evaporation pond.
